**Flood Control Project Maintenance  
Levee Inspections**

**Fall 2018 Levee Maintenance Deficiency Summary Report**

**Sacramento River Basin**

**Sacramento Maintenance Yard Putah Creek**

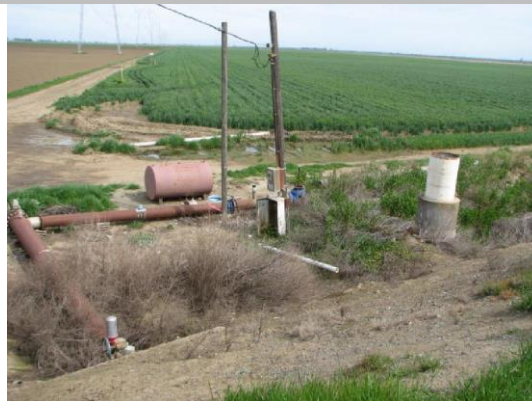
Photo 2 of 3 : UCIP\_FA\_2018\_48122\_60483.jpg

Comment Code						
Inspector Comment						
FS_ID:48122 DS_ID:489 EP_NO: 10262 Repair Type: Non-Urgent Crossing Status: Found UCIP Comments: Pump is disconnected from pipe and could cause backflow at highwater event. Can't see size of pipe sleeved through 24-inch pipe. FIELD_STRUCT_DESC: 18-inch steel irrigation pipe (field verified not 16-inch) sleeved through existing 24-inch drainage steel pipe through levee, 12.5 feet below the crown. Annular space sealed at both the waterside (WS) and landside (LS) ends. Concrete headwalls are located on both the WS and LS ends. PVC sleeved December of 2007 (unknown source). (16-inch pipe sleeved through 24-inch pipe authorized under Automatic Board Order (ABO) issued as Permit No. 10262, 1974 - Wells Fargo Bank, Trustee for S.H. Cowell Foundation) [Additional Reference(s): DWR Levee Log, March 2007. USACE Sacramento O&M Manual 119, December 1952] FS Date: 4/10/2014 2:48:00 PM

pipe and pump/appurtenances on LS

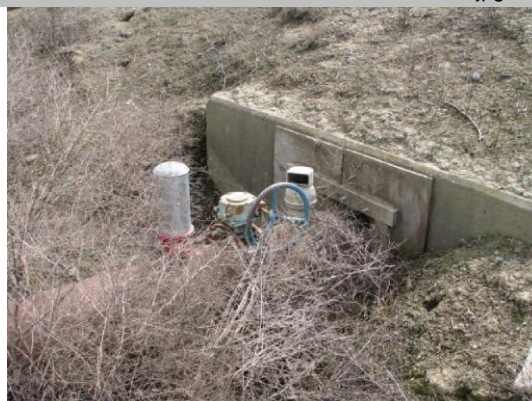
Photo 3 of 3 : UCIP\_FA\_2018\_48122\_60482.jpg

Comment Code						
Inspector Comment						
FS_ID:48122 DS_ID:489 EP_NO: 10262 Repair Type: Non-Urgent Crossing Status: Found UCIP Comments: Pump is disconnected from pipe and could cause backflow at highwater event. Can't see size of pipe sleeved through 24-inch pipe. FIELD_STRUCT_DESC: 18-inch steel irrigation pipe (field verified not 16-inch) sleeved through existing 24-inch drainage steel pipe through levee, 12.5 feet below the crown. Annular space sealed at both the waterside (WS) and landside (LS) ends. Concrete headwalls are located on both the WS and LS ends. PVC sleeved December of 2007 (unknown source). (16-inch pipe sleeved through 24-inch pipe authorized under Automatic Board Order (ABO) issued as Permit No. 10262, 1974 - Wells Fargo Bank, Trustee for S.H. Cowell Foundation) [Additional Reference(s): DWR Levee Log, March 2007. USACE Sacramento O&M Manual 119, December 1952] FS Date: 4/10/2014 2:48:00 PM

Butterfly valve at LS toe

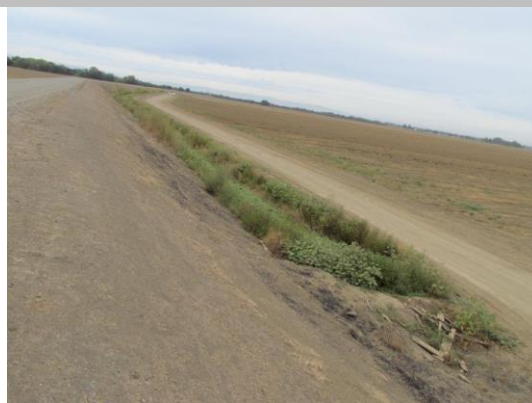
Photo 1 of 1 : FA\_2018\_ST0007\_282\_10\_20180925\_00004.jpg

LM Start	1.52	Rating **	M	Issue No.	10
LM End	2.67	Issue Type +	En	Location *	LS
Category	Earthen Levee			GPS Latitude/Longitude	
				Start	End
Item	Encroachments			38.515258 °	38.517376 °
				-121.655107 °	-121.676054 °
DWR ID	DWR_ST0007_01_s_2012_10				
Comment Code					
DT : Ditch					
Inspector Comment					
This agriculture ditch is owned by Dos Rios Farms. Ending at levee mile 2.72 landside.

Agriculture ditch within 10-foot of levee toe.

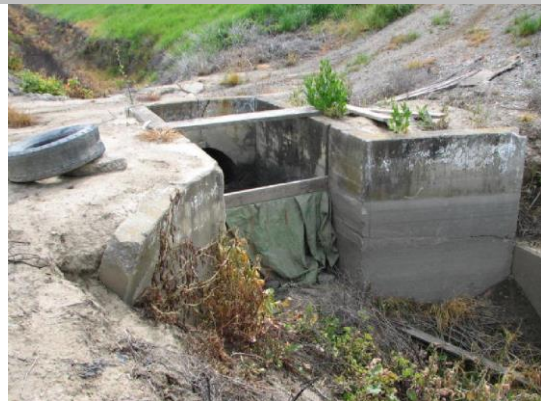
Photo 2 of 3 : UCIP\_FA\_2018\_43033\_60467.jpg

Comment Code					
Inspector Comment					
FS_ID:43033 DS_ID:491 EP_NO: 10262 Repair Type: Non-Urgent Crossing Status: Found UCIP Comments: 09/21/2017 Pipe was permitted as an irrigation structure under ABO issued as Permit No. 10262. (DWR UCIP - O. Magana) 04/03/2012 Pipe has significant rust and exfoliation of metal showing at ends. Reccomend video inspection. (DWR UCIP - W. Wylie) FIELD_STRUCT_DESC: 24-inch irrigation pipe of unknown material through levee, 15.5 feet below crown. Slide gate is located on the waterside (WS) end. Concrete headwall is located on the landside (LS) end. (24-inch pipe [HLM 2.17] authorized under Automatic Board Order (ABO) issued as Permit No. 10262, 1974 - Wells Fargo Bank, Trustee for S.H. Cowell Foundation) [Additional Reference(s): DWR Levee Log, 1981 and 2005. USACE Sacramento O&M Manual Unit 119, December 1952, (Station XX+XX)] FS Date: 4/10/2014 2:45:00 PM

LS distribution box

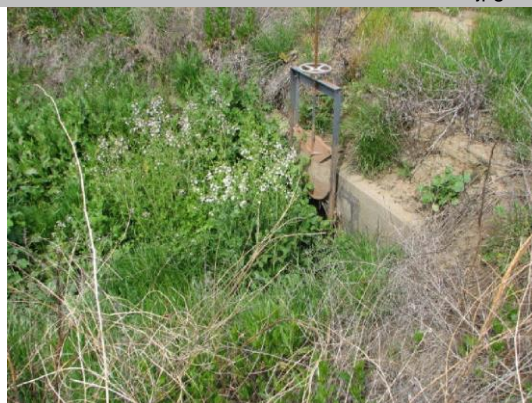
Photo 3 of 3 : UCIP\_FA\_2018\_43033\_60466.jpg

Comment Code						
Inspector Comment						
FS_ID:43033 DS_ID:491 EP_NO: 10262 Repair Type: Non-Urgent Crossing Status: Found UCIP Comments: 09/21/2017 Pipe was permitted as an irrigation structure under ABO issued as Permit No. 10262. (DWR UCIP - O. Magana) 04/03/2012 Pipe has significant rust and exfoliation of metal showing at ends. Reccomend video inspection. (DWR UCIP - W. Wylie) FIELD_STRUCT_DESC: 24-inch irrigation pipe of unknown material through levee, 15.5 feet below crown. Slide gate is located on the waterside (WS) end. Concrete headwall is located on the landside (LS) end. (24-inch pipe [HLM 2.17] authorized under Automatic Board Order (ABO) issued as Permit No. 10262, 1974 - Wells Fargo Bank, Trustee for S.H. Cowell Foundation) [Additional Reference(s): DWR Levee Log, 1981 and 2005. USACE Sacramento O&M Manual Unit 119, December 1952, (Station XX+XX)] FS Date: 4/10/2014 2:45:00 PM

WS slide gate with vegetation

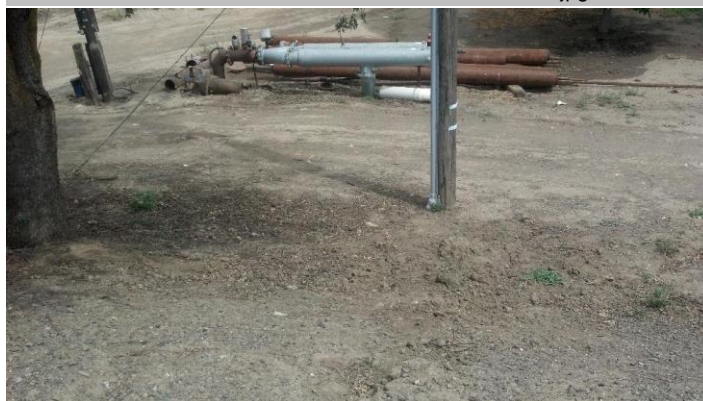
Photo 1 of 3 : UCIP\_FA\_2018\_48013\_60451.jpg

LM Start	3.22	Rating **	M	Issue No.	61	
LM End	3.22	Issue Type +	En	Location *		
Category	Supplemental			GPS Latitude/Longitude		
				Start		End
Item	DWR UCIP Field Study			38.519731 °		38.519731 °
				-121.685681 °		-121.685681 °
DWR ID	16849					
Comment Code						
Inspector Comment						
FS_ID:48013 DS_ID:16849 EP_NO: N/A Repair Type: Non-Urgent Crossing Status: Found UCIP Comments: Old pipe and concrete hauled to county dump. Evidence of the 14-inch pipe is no longer present at site. See new picture. FIELD_STRUCT_DESC: 10-inch steel irrigation pipe through the levee, 12 feet below the crown. Pipe terminates at standpipe located on the waterside (WS) approximately 500 feet south of levee. Mobile pumping plant is located in the floodway at edge of stream 740 feet south of levee. FS Date: 4/10/2014 2:42:00 PM

Filter Plant on LS toe

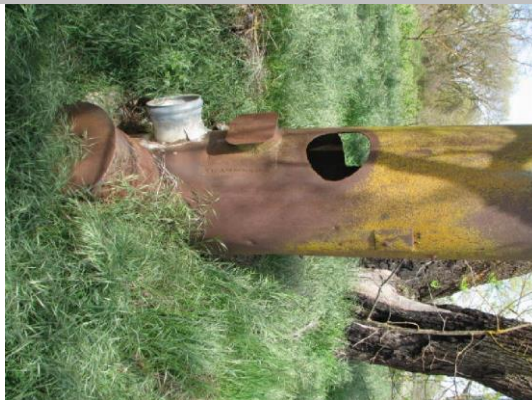
Photo 2 of 3 : UCIP\_FA\_2018\_48013\_60448.jpg

Steel Standpipe at 10-inch pipe termination 500-feet south of levee

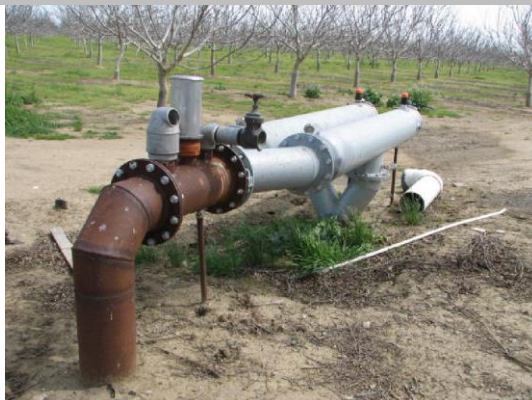
Photo 3 of 3 : UCIP\_FA\_2018\_48013\_60450.jpg

10-inch pipe at LS toe.

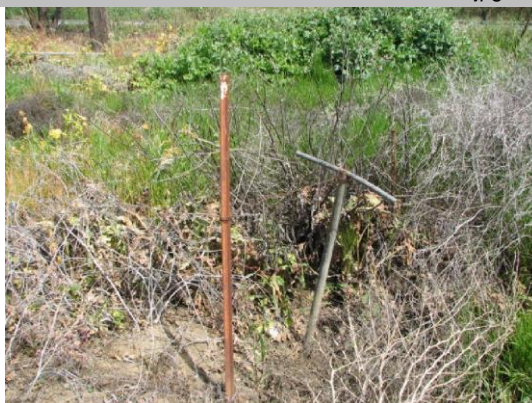
Photo 1 of 3 : UCIP\_FA\_2018\_33381\_60439.jpg

Comment Code					
Inspector Comment					
FS_ID:33381 DS_ID:496 EP_NO: 10251 Repair Type: No Action Needed Crossing Status: Found UCIP Comments: FIELD_STRUCT_DESC: 24-inch corrugated metal drainage pipe through levee, 15 feet below the crown. Two metal cutoff walls were installed through the levee. A T-post and T-handle are located on the landside (LS) toe. The outfall structure and flap gate are located on the west side of bridge, waterside (WS). (24-inch pipe [HLM 3.87] authorized under Automatic Board Order (ABO) issued as Permit No. 10251, 1974 - F.M.C. Corp.) [Additional Reference(s): DWR Levee Log, 1981 and 2005. USACE Sacramento O&M Manual Unit 119, December 1952, (Station XX+XX)] FS Date: 4/10/2014 2:40:30 PM

WS toe at T handle. No access to pipe.

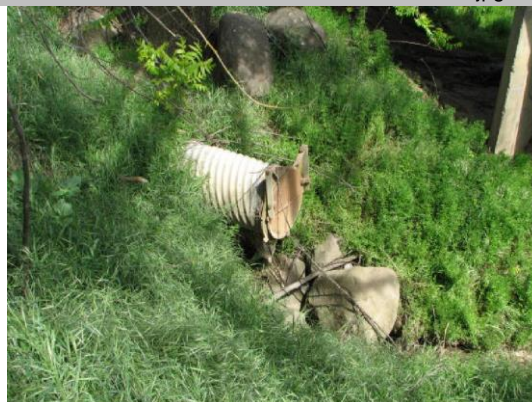
Photo 3 of 3 : UCIP\_FA\_2018\_33381\_60440.jpg

Outfall at creek with flap gate.

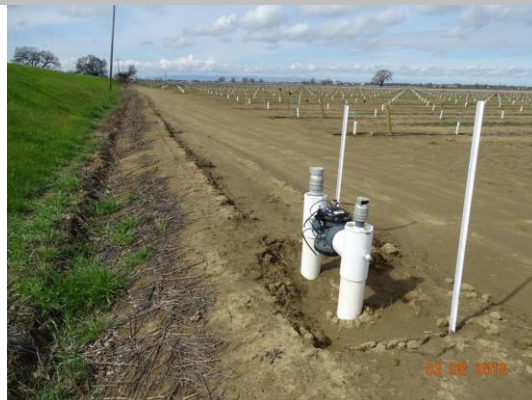
Photo 1 of 2 : FA\_2018\_ST0007\_282\_39\_20180925\_00008.jpg

Visible riser on suspected new pipeline running parallel to levee, 8 feet from toe.

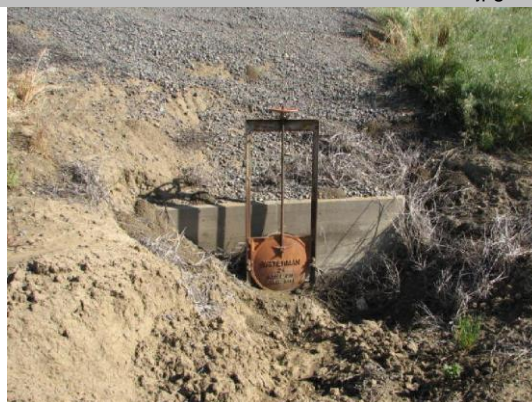
Photo 2 of 3 : UCIP\_FA\_2018\_33371\_60416.jpg

Comment Code						
Inspector Comment						
FS_ID:33371						
DS_ID:500						
EP_NO: 10256						
Repair Type: No Action Needed						
Crossing Status: Found						
UCIP Comments: Debris removed. See picture						
FIELD_STRUCT_DESC: 24-inch corrugated metal drainage pipe						
through the levee, 15 feet below the crown. Slide gate on the waterside						
(WS) end. Concrete headwall on the landside (LS) end. (24-inch pipe						
[HLM 5.39] authorized under Automatic Board Order (ABO) issued as						
Permit No. 10256, 1974 - Albert H. Lederer). [Additional Reference(s):						
DWR Levee Log, 2005. USACE Sacramento O&M Manual 119,						
December 1952, (Station 83+70 PCT)].						
FS Date: 4/10/2014 2:37:39 PM

WS slide gate

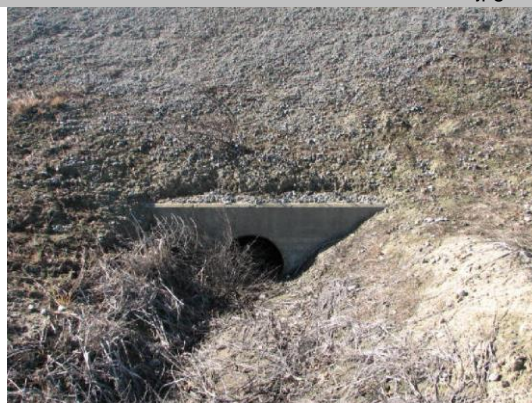
Photo 3 of 3 : UCIP\_FA\_2018\_33371\_60417.jpg

Comment Code						
Inspector Comment						
FS_ID:33371						
DS_ID:500						
EP_NO: 10256						
Repair Type: No Action Needed						
Crossing Status: Found						
UCIP Comments: Debris removed. See picture						
FIELD_STRUCT_DESC: 24-inch corrugated metal drainage pipe through the levee, 15 feet below the crown. Slide gate on the waterside (WS) end. Concrete headwall on the landside (LS) end. (24-inch pipe [HLM 5.39] authorized under Automatic Board Order (ABO) issued as Permit No. 10256, 1974 - Albert H. Lederer). [Additional Reference(s): DWR Levee Log, 2005. USACE Sacramento O&M Manual 119, December 1952, (Station 83+70 PCT)].						
FS Date: 4/10/2014 2:37:39 PM

LS headwall showing debris

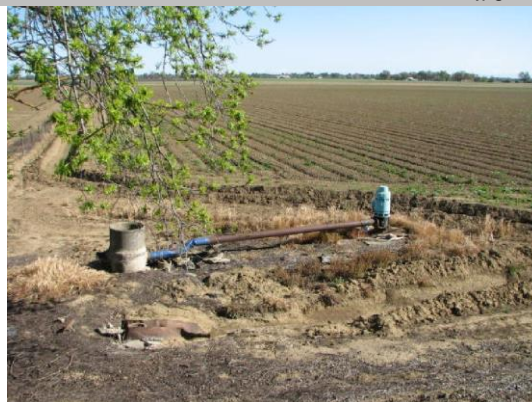
Photo 1 of 2 : UCIP\_FA\_2018\_33370\_60415.jpg

Comment Code						
Inspector Comment						
FS_ID:33370						
DS_ID:501						
EP_NO: 10256						
Repair Type: No Action Needed						
Crossing Status: Found						
UCIP Comments:						
FIELD_STRUCT_DESC: 24-inch corrugated metal drainage pipe through the levee, 12.5 feet below the crown. Slide gate on the waterside (WS) end in 36-inch standpipe. Concrete headwall on the landside (LS) end. (24-inch pipe [HLM 5.40] authorized under Automatic Board Order (ABO) issued as Permit No. 10256, 1974 - Albert H. Lederer). [Additional Reference(s): DWR Levee Log, 2005. USACE Sacramento O&M Manual 119, December 1952, (Station 84+40 PCT)].						
FS Date: 4/10/2014 2:36:12 PM

LS pump and stand pipe

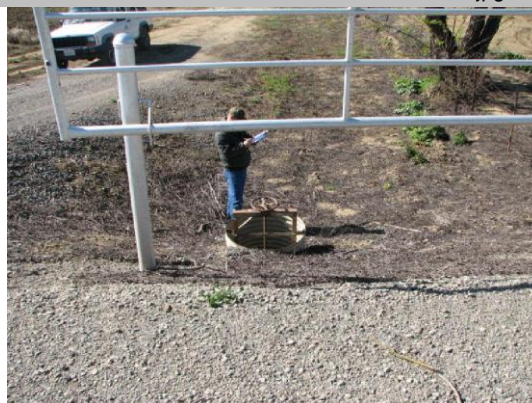
Photo 2 of 2 : UCIP\_FA\_2018\_33370\_60414.jpg

WS slide gate in 36-inch cmp standpipe

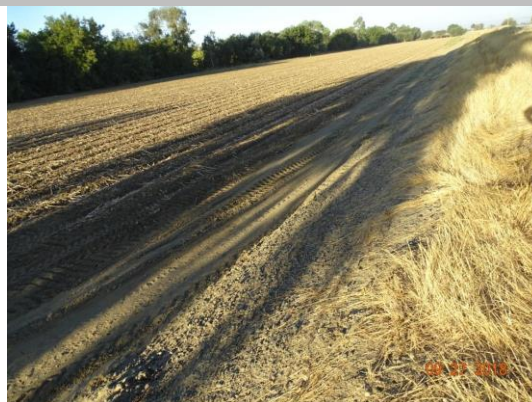
Photo 1 of 2 : FA\_2018\_ST0007\_282\_50\_20180928\_00069.jpg

LM Start	5.31	Rating **	A/W	Issue No.	50
LM End	5.39	Issue Type +	En	Location *	WS
Category	Earthen Levee			GPS Latitude/Longitude	
				Start	End
Item	Encroachments			38.518048 °	38.518132 °
				-121.723033 °	-121.724473 °
DWR ID	DWR_ST0007_01_f_2017_50				
Comment Code					
AT : Agricultural tilling					
Inspector Comment					
Access road now present where agricultural tilling was.

View looking upstream at the access road where the agricultural tilling was previously (September 2018).

Agricultural tilling has encroached into waterside levee toe. Activity should cease and toe should be repaired.

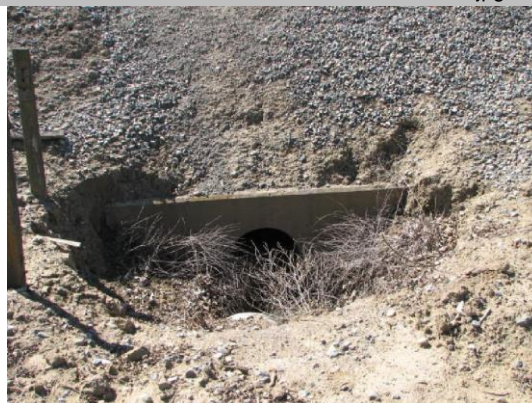
Photo 1 of 2 : UCIP\_FA\_2018\_33368\_60410.jpg

LM Start	5.56	Rating **	A/W	Issue No.	66
LM End	5.56	Issue Type +	Ma	Location *	
Category	Supplemental			GPS Latitude/Longitude	
				Start	End
Item	DWR UCIP LMA Responsibility			38.518249 °	38.518249 °
				-121.727538 °	-121.727538 °
DWR ID	502				
Comment Code					
Inspector Comment					
FS_ID:33368					
DS_ID:502					
EP_NO: 10255					
Repair Type: No Action Needed					
Crossing Status: Found					
UCIP Comments:					
FIELD_STRUCT_DESC: 24-inch corrugated metal drainage pipe through the levee, 11 feet below the crown. Slide gate on the waterside (WS) end. Concrete headwall on the landside (LS) end. (24-inch pipe [HLM 5.67] authorized under Automatic Board Order (ABO) issued as Permit No. 10255, 1974 - Owen W. and Ray W. Hamel). [Additional Reference(s): DWR Levee Log, 2005. USACE Sacramento O&M Manual 119, December 1952, (Station 97+00 PCT)].					
FS Date: 4/10/2014 2:35:43 PM

LS headwall

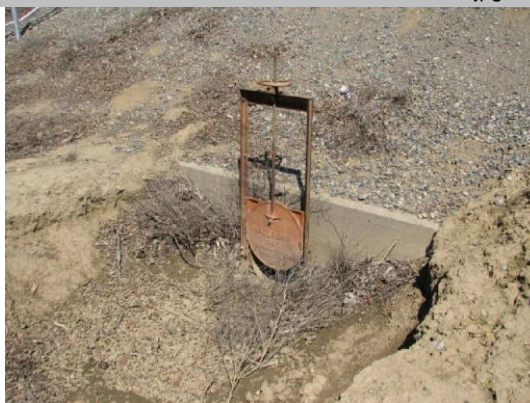
Photo 2 of 2 : UCIP\_FA\_2018\_33368\_60409.jpg

WS slide gate

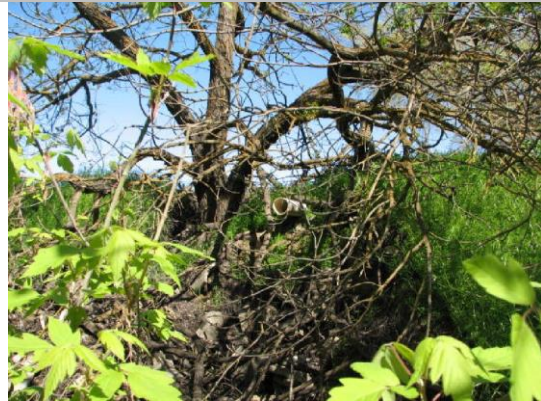
Photo 2 of 3 : UCIP\_FA\_2018\_33367\_60408.jpg

Comment Code						
Inspector Comment						
FS_ID:33367						
DS_ID:590						
EP_NO: 14140						
Repair Type: Non-Urgent						
Crossing Status: Found						
UCIP Comments: Air vent broken off on water side shoulder. Also, no flap gate or other positive closure device on either side of levee. No requirement in permit for applicant to install positive closure device, but it may be necessary if maintenance or upgrade is performed on pipe.						
FIELD_STRUCT_DESC: 6-inch polyvinyl chloride (PVC) drainage pipe though the levee, 16 feet below the crown. 24-inch standpipe with pump on the landside (LS). Pipe outfall at creek with riprap.						
FS Date: 4/10/2014 2:35:30 PM

WS outfall at creek bank

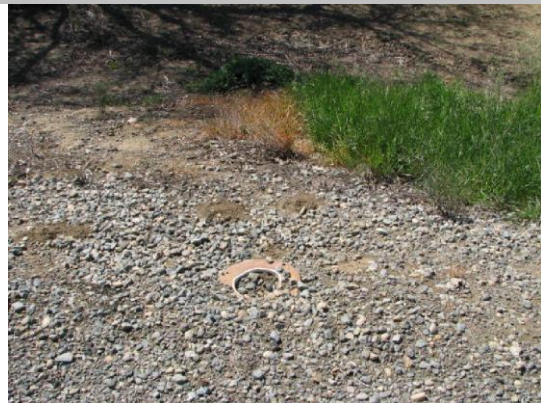
Photo 3 of 3 : UCIP\_FA\_2018\_33367\_60407.jpg

WS shoulder broken air vent

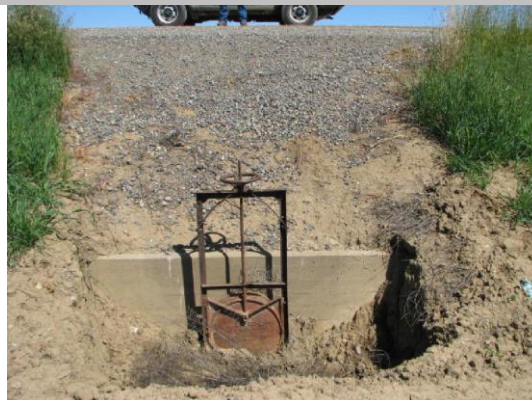
Photo 2 of 2 : UCIP\_FA\_2018\_33364\_60400.jpg

WS headwall and slidegate

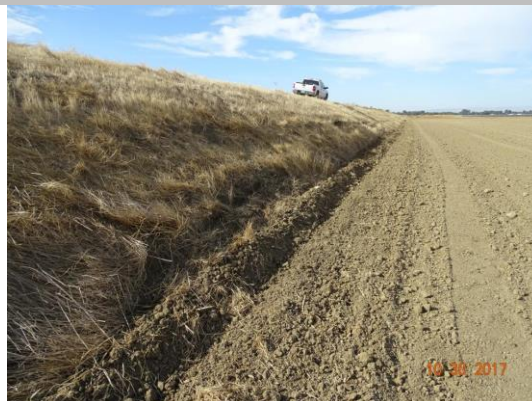
Photo 2 of 3 : FA\_2018\_ST0007\_282\_53\_20180925\_00011.jpg

Agricultural tilling has encroached into landside levee toe. Activity should cease and toe should be repaired.

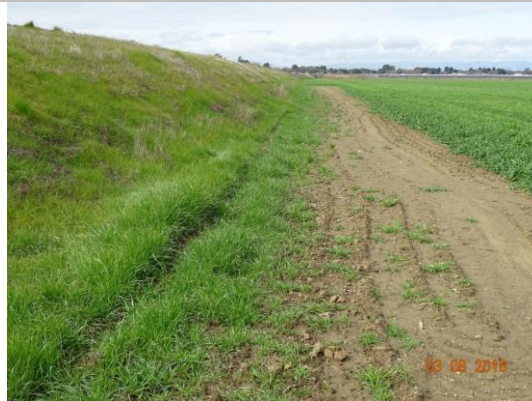
Photo 3 of 3 : FA\_2018\_ST0007\_282\_53\_20180925\_00012.jpg

Fleld not currently planted in area were tilling previously encroached on levee toe. Continue to monitor. Toe should be repaired.

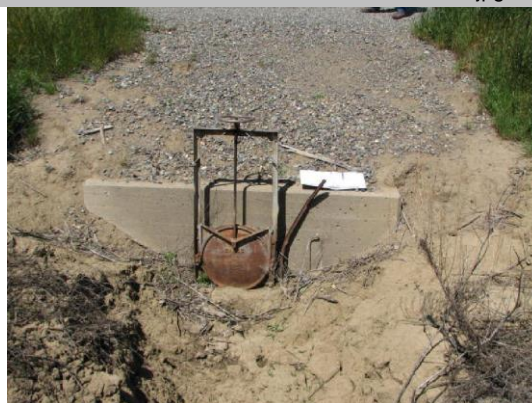
Photo 1 of 2 : UCIP\_FA\_2018\_33349\_60372.jpg

WS Slide Gate

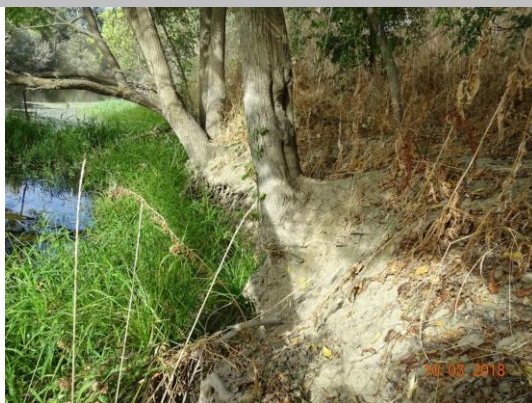
Photo 1 of 1 : FA\_2018\_ST0007\_282\_34\_20181003\_00074.jpg

View looking upstream at erosion at the water side toe. Tree roots are exposed (September 2018).

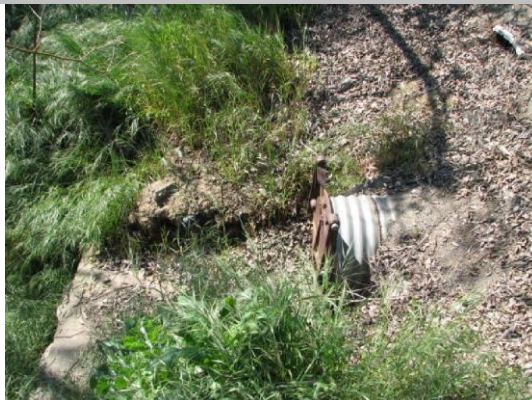
Photo 1 of 3 : UCIP\_FA\_2018\_33343\_60357.jpg

WS flap gate

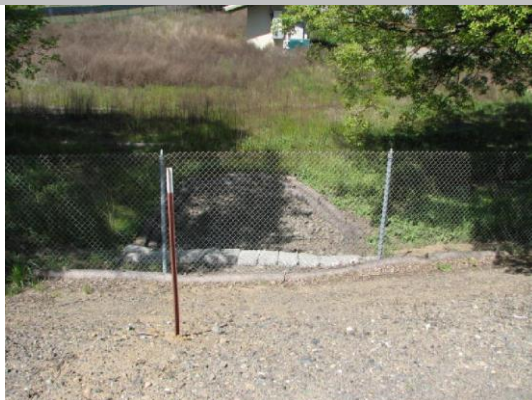
Photo 2 of 3 : UCIP\_FA\_2018\_33343\_60359.jpg

LS headwall

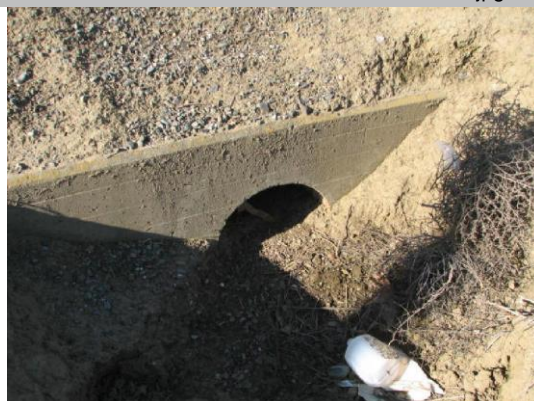
Photo 2 of 2 : UCIP\_FA\_2018\_41353\_60344.jpg

LS headwall showing pipe partially blocked with soil.

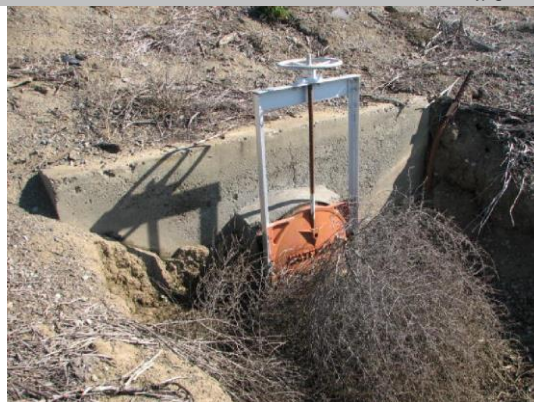
Photo 1 of 2 : UCIP\_FA\_2018\_33333\_60342.jpg

WS headwall and slide gate

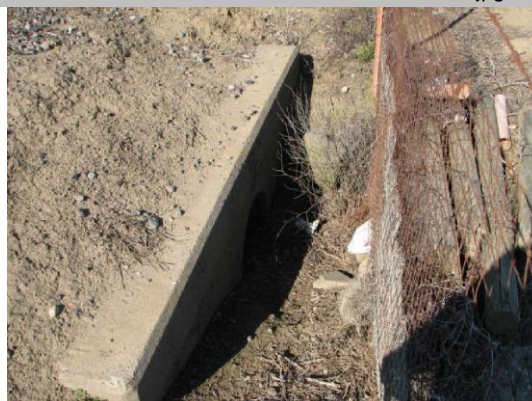
Photo 2 of 2 : UCIP\_FA\_2018\_33333\_60341.jpg

LS headwall showing fence and soil buildup.

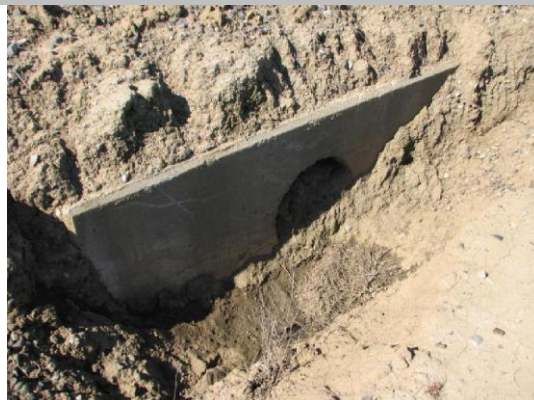
Photo 2 of 3 : UCIP\_FA\_2018\_33328\_60327.jpg

LS headwall showing pipe plugged with soil

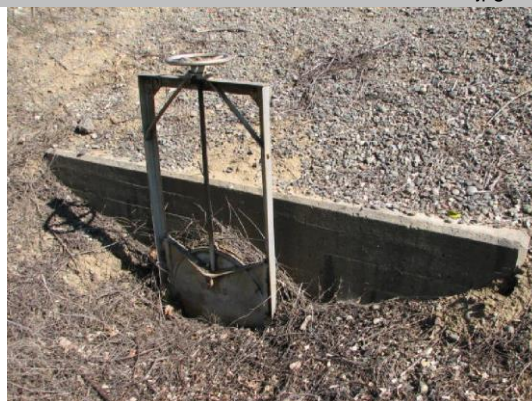
Photo 3 of 3 : UCIP\_FA\_2018\_33328\_60328.jpg

WS slide gate showing some blockage with soil.

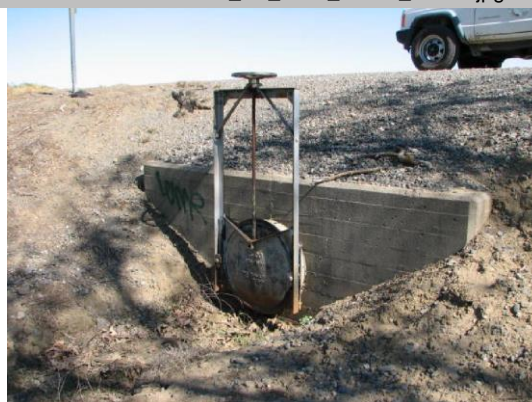
Photo 1 of 2 : UCIP\_FA\_2018\_33327\_60326.jpg

WS headwall and slidegate

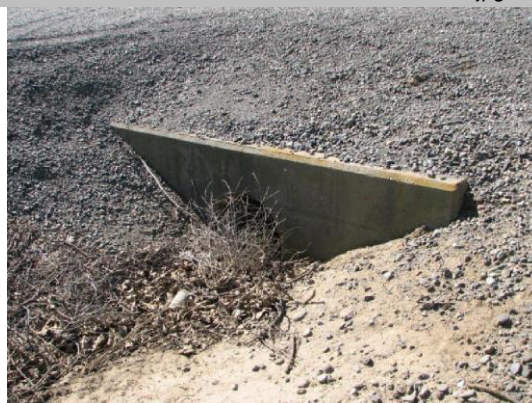
Photo 2 of 2 : UCIP\_FA\_2018\_33327\_60325.jpg

LS headwall showing partial blockage

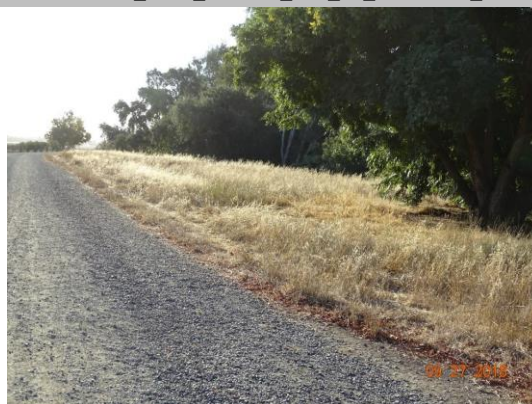
Photo 1 of 1 : FA\_2018\_ST0007\_282\_29\_20180928\_00073.jpg

View looking downstream at thick vegetation up to the crown (September 2018).

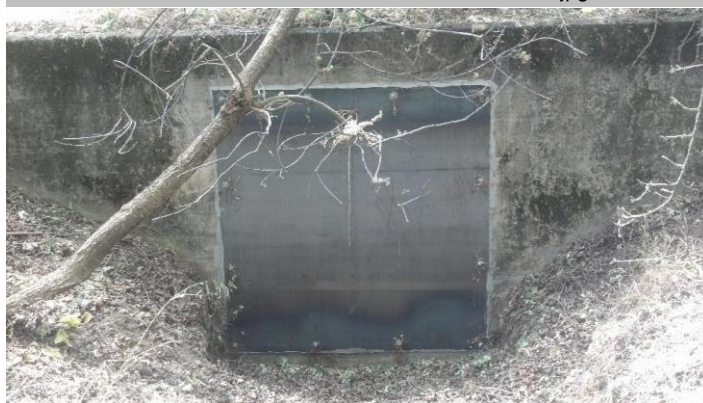
Photo 1 of 3 : UCIP\_FA\_2018\_41129\_60301.jpg

Steel plate installed over pipe off LS toe.

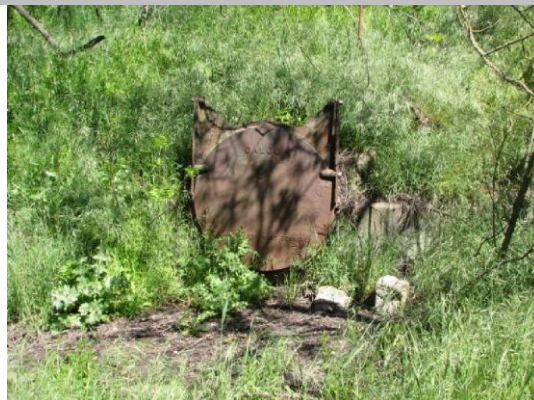
Photo 3 of 3 : UCIP\_FA\_2018\_41129\_60300.jpg

WS flap gate

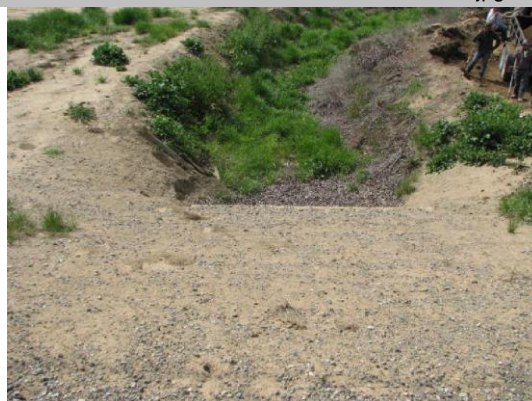
Photo 1 of 3 : UCIP\_FA\_2018\_33407\_60489.jpg

L/S inlet

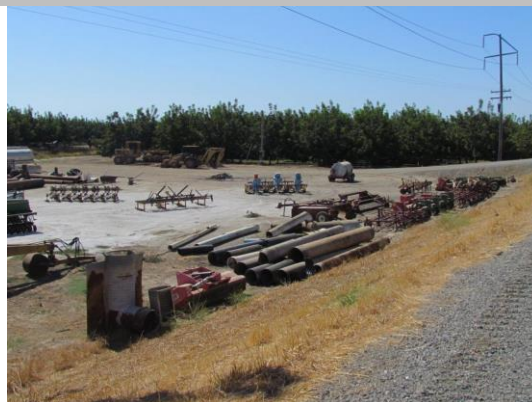
Photo 1 of 1 : FA\_2018\_ST0007\_283\_23\_20180924\_00003.jpg

Levee mile 1.01 landside toe looking upstream.

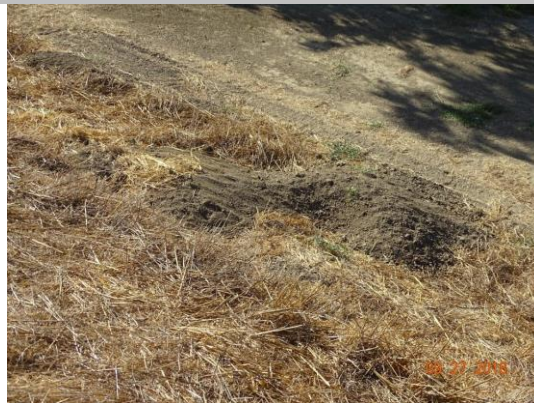
Photo 3 of 3 : FA\_2018\_ST0007\_283\_32\_20180928\_00063.jpg

View looking down slope at one of the animal holes on the levee slope with fresh dirt in front of the hole (September 2018).

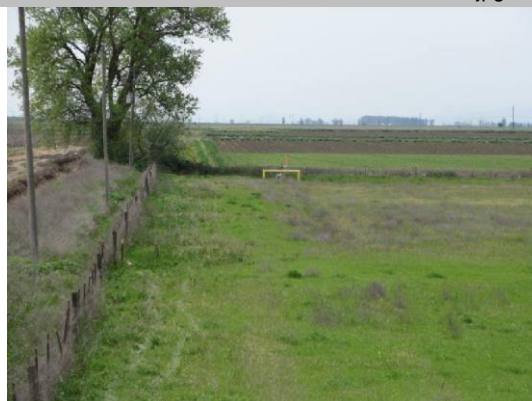
Photo 1 of 3 : UCIP\_FA\_2018\_33400\_60474.jpg

Gas vent 800-feet to south

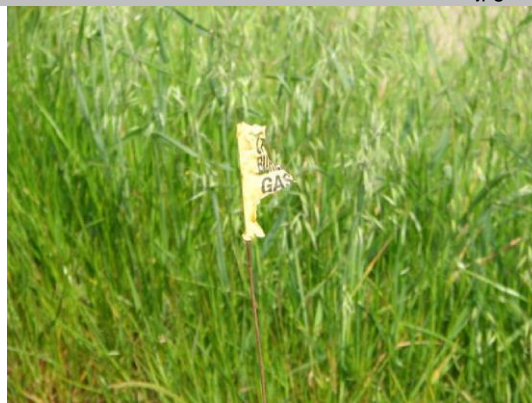
Photo 2 of 3 : UCIP\_FA\_2018\_33400\_60472.jpg

small flag on WS shoulder

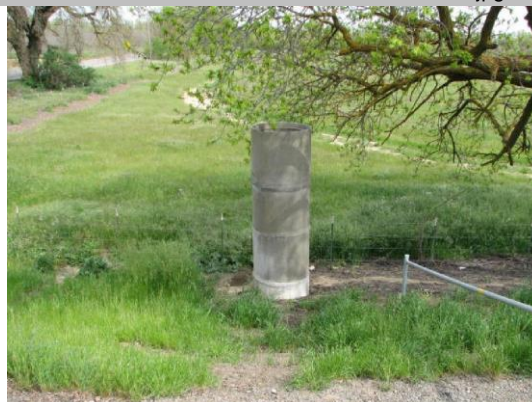
Photo 2 of 3 : UCIP\_FA\_2018\_41072\_60471.jpg

36-inch standpipe WS toe

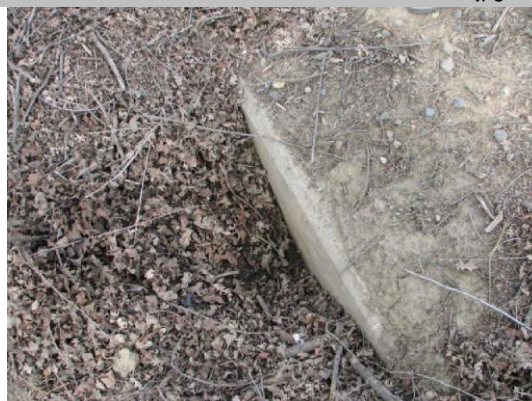
Photo 3 of 3 : UCIP\_FA\_2018\_41072\_60470.jpg

LS headwall.

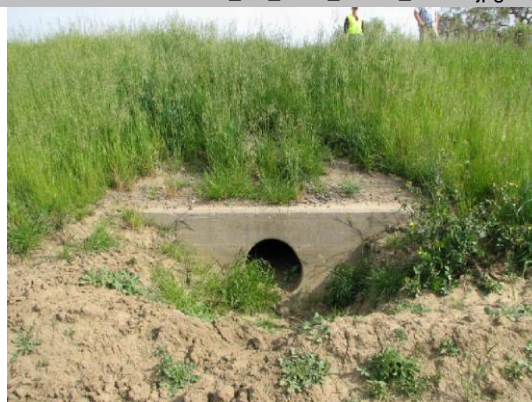
Photo 1 of 2 : UCIP\_FA\_2018\_33395\_60460.jpg

LS headwall

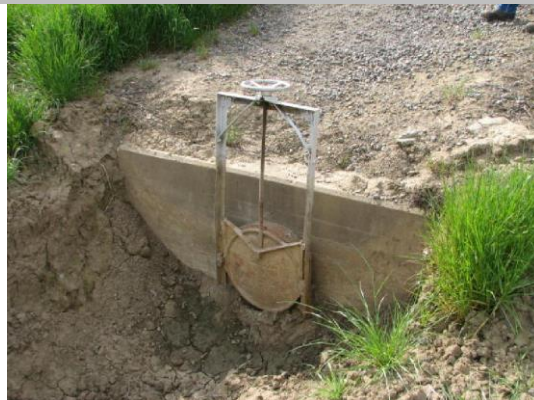
Photo 2 of 2 : UCIP\_FA\_2018\_33395\_60459.jpg

WS headwall and slide gate

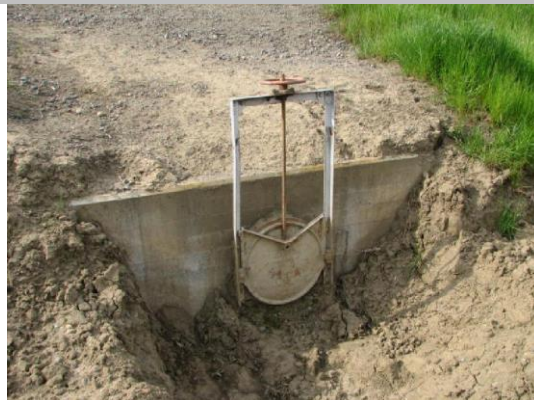
Photo 1 of 2 : UCIP\_FA\_2018\_33393\_60456.jpg

WS headwall and slide gate

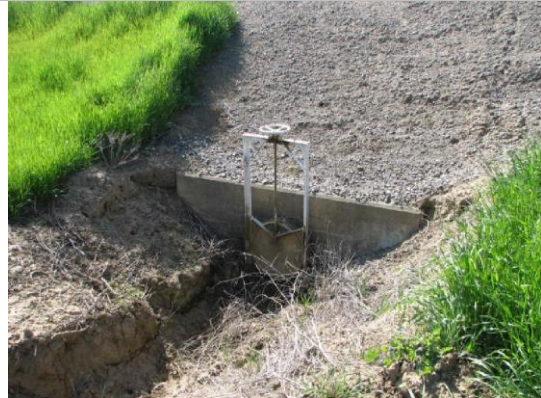
Photo 2 of 2 : UCIP\_FA\_2018\_33378\_60434.jpg

WS slide gate and headwall

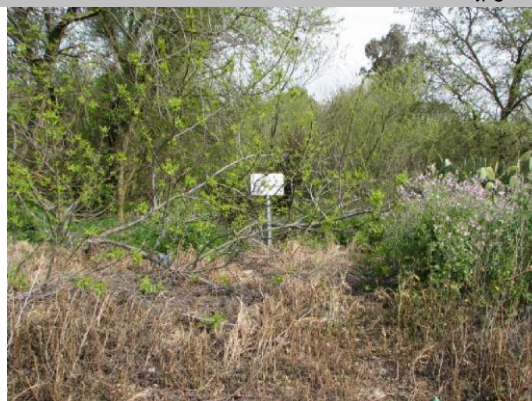
Photo 1 of 2 : UCIP\_FA\_2018\_33377\_60433.jpg

WS marker 320 feet north of levee at stream bank.

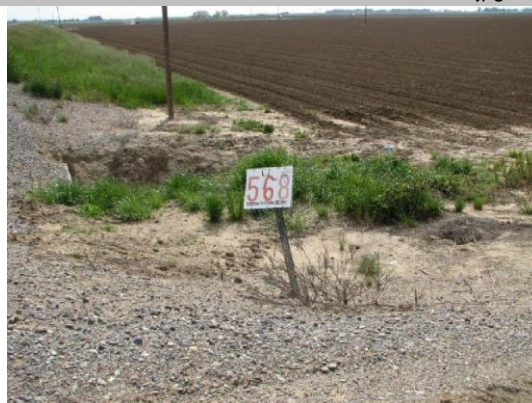
Photo 2 of 2 : UCIP\_FA\_2018\_33377\_60432.jpg

LS marker on east side of access ramp.

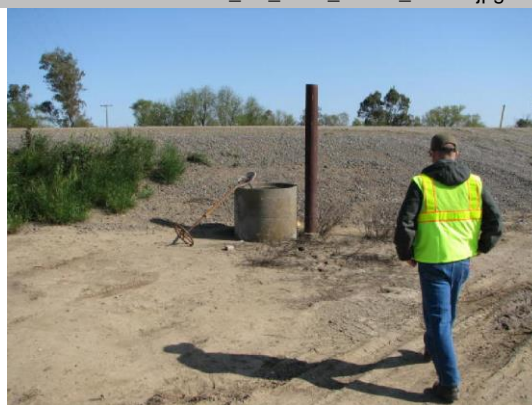
Photo 1 of 3 : UCIP\_FA\_2018\_33375\_60427.jpg

LS 36-inch standpipe

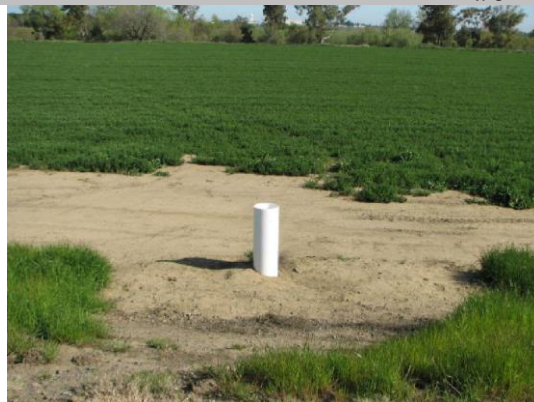
Photo 1 of 1 : UCIP\_FA\_2018\_41074\_60419.jpg

15-inch standpipe at location where may run through 24-inch SD.

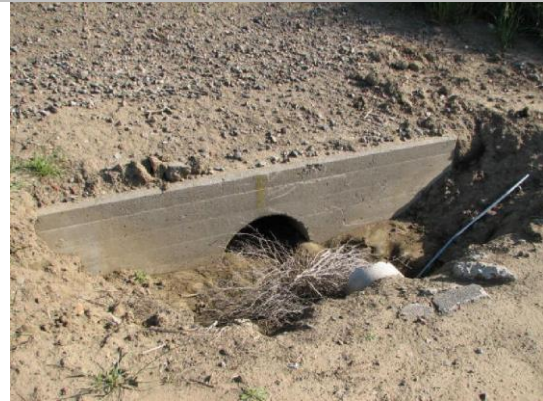
Photo 2 of 3 : UCIP\_FA\_2018\_33369\_60413.jpg

L/S Clogged

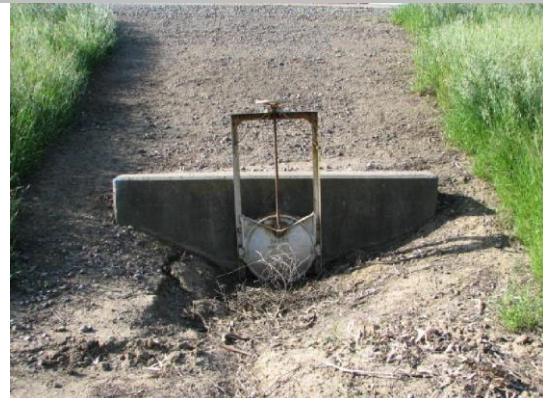
Photo 3 of 3 : UCIP\_FA\_2018\_33369\_60412.jpg

W/S positive closure device

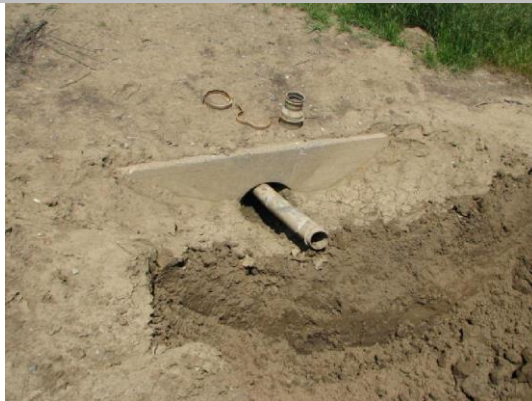
Photo 2 of 2 : UCIP\_FA\_2018\_33363\_60398.jpg

LS headwall showing sedimentation and 6-inch pipe sleeved through 24-inch pipe.

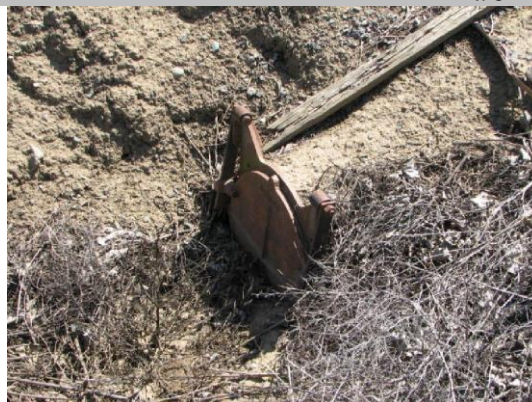
Photo 1 of 2 : UCIP\_FA\_2018\_42953\_60397.jpg

WS Flapgate blocked by sedimentation

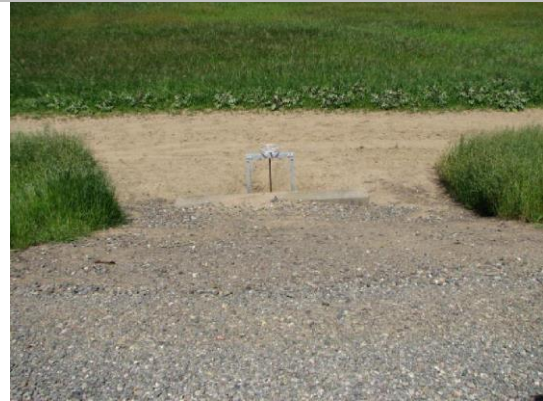
Photo 2 of 2 : UCIP\_FA\_2018\_33353\_60379.jpg

WS slide gate

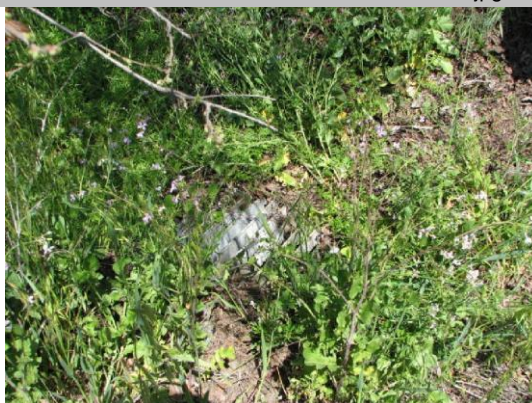
Photo 1 of 3 : UCIP\_FA\_2018\_33348\_60367.jpg

Dropinlet at LS toe.

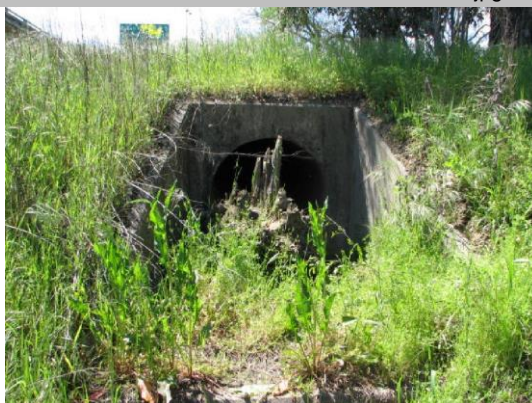
Photo 3 of 3 : UCIP\_FA\_2018\_33348\_60369.jpg

WS headwall and outfall showing rootball blocking pipe

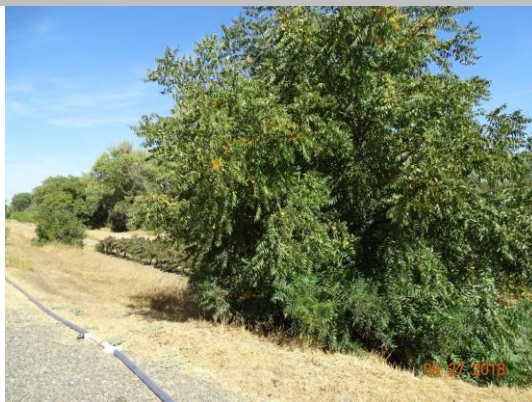
Photo 1 of 1 : FA\_2018\_ST0007\_283\_39\_20180928\_00065.jpg

View looking upstream of walnut trees on the water side slope (September 2018).
